# Assessment of Dam Safety Coal Combustion Surface Impoundments Draft Report

American Electric Power  
General James Gavin  
Power Plant  
Cheshire, Ohio

July 2, 2009

CHA Project No. 20085.4000.1510

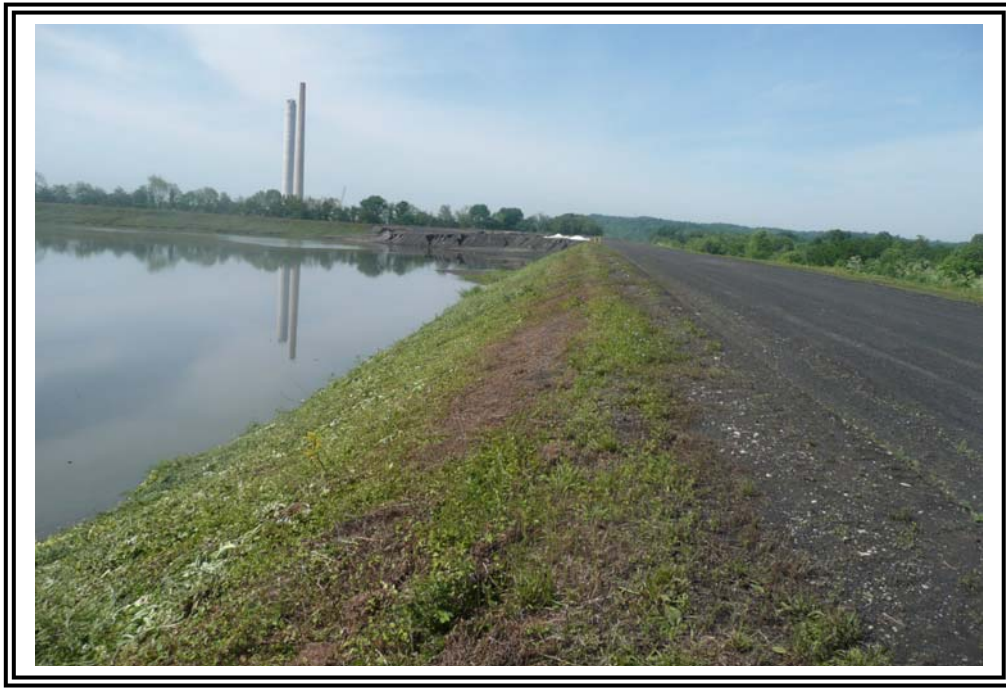
1

Upstream slope of the west dike, looking south.

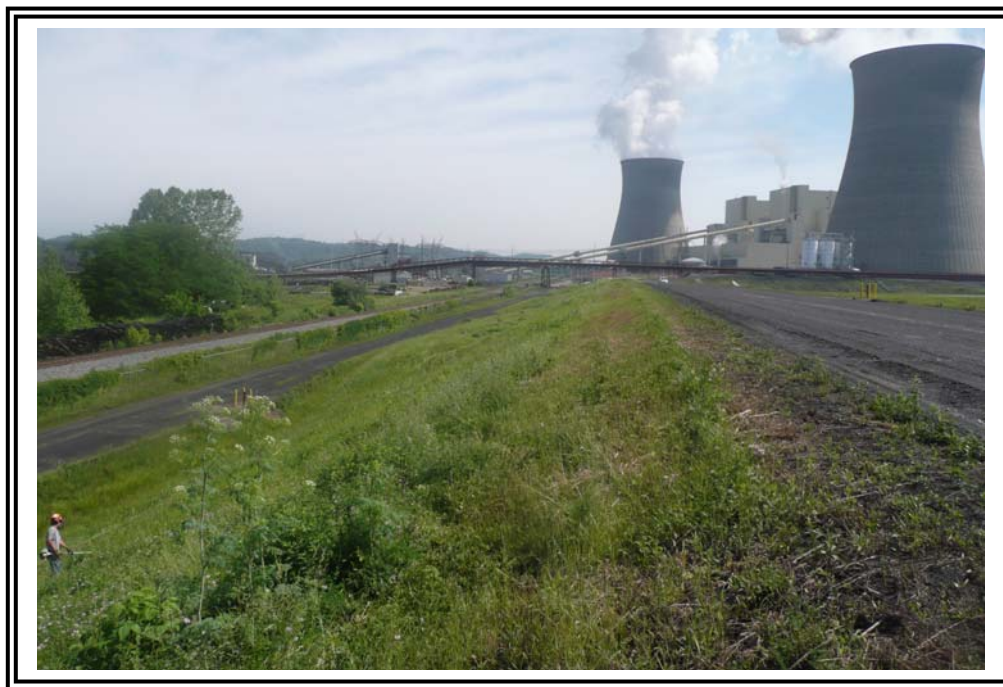
3

Downstream slope of the west dike, looking north.

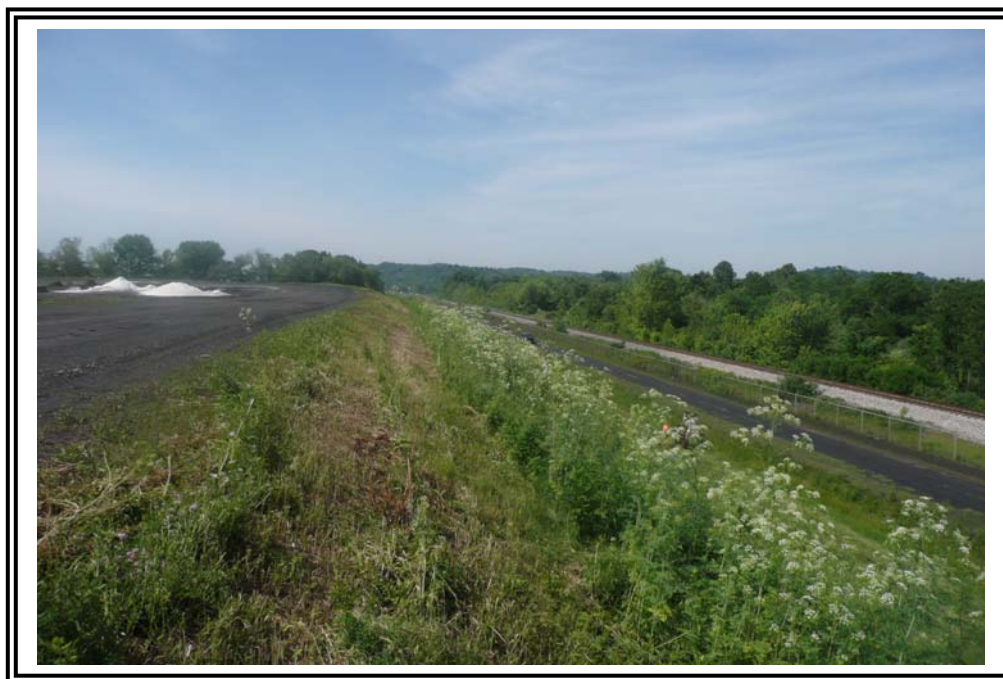
4

Downstream slope of the west dike, looking south. Note that weed-whacking was in progress and is reportedly performed twice a year.

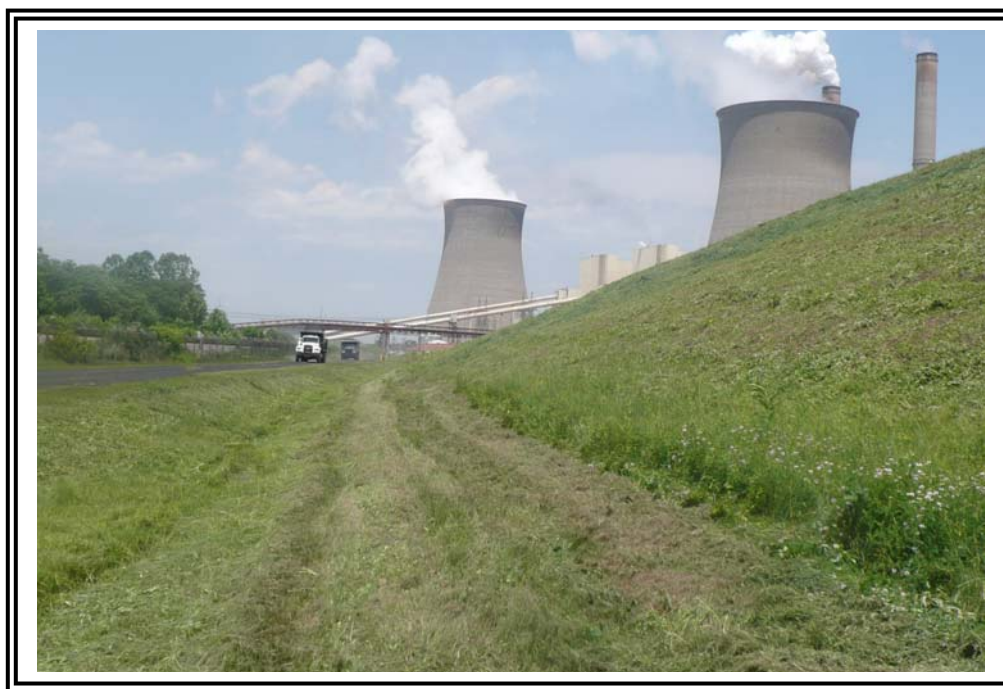
5

Downstream toe of the west dike, looking north.

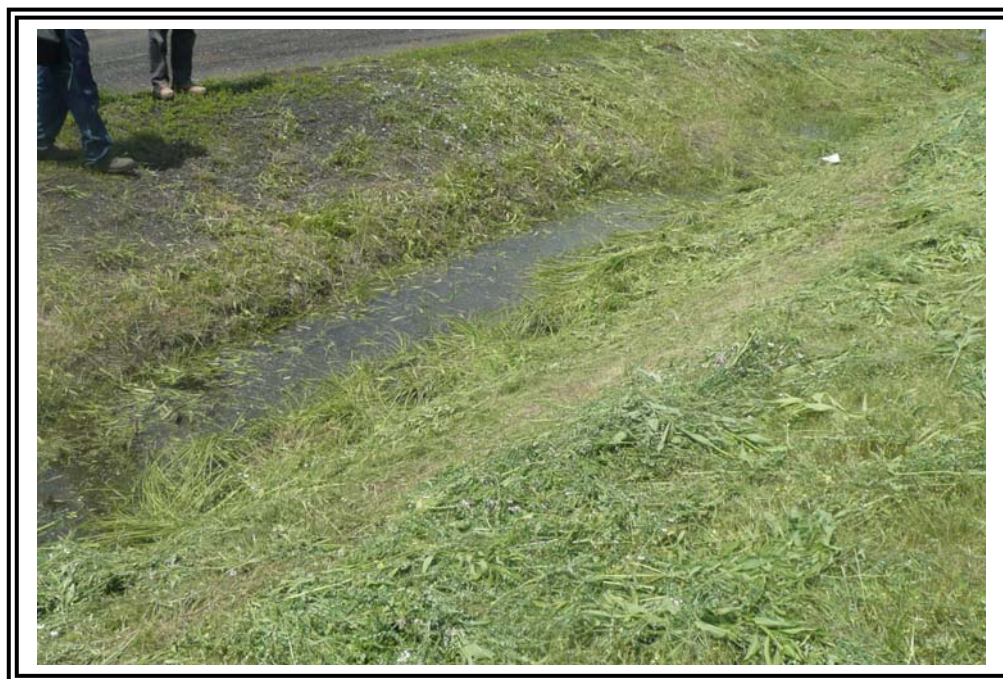
6

Standing water in drainage swale at toe of west dike. Appears related to surface water runoff. Piezometer readings confirm groundwater is well below the ground surface.

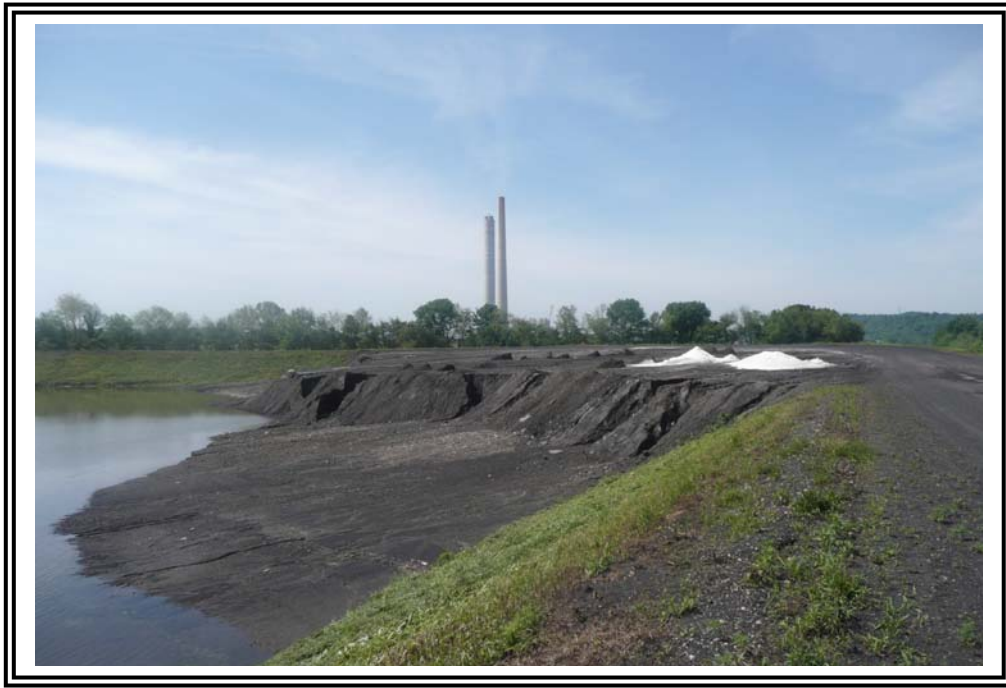
7

Southwest corner of the bottom ash pond. Area used for trucked in bottom ash from various cleaning operations.

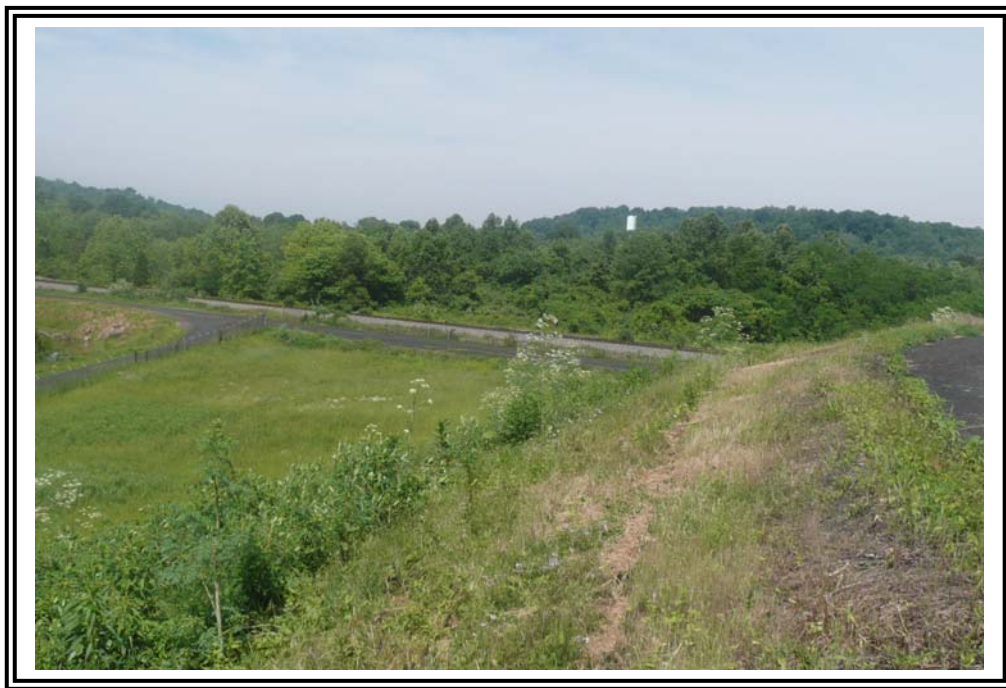
8

Downstream slope at southwest corner, looking west. Note that weed-whacking was in progress and is reportedly performed twice a year.

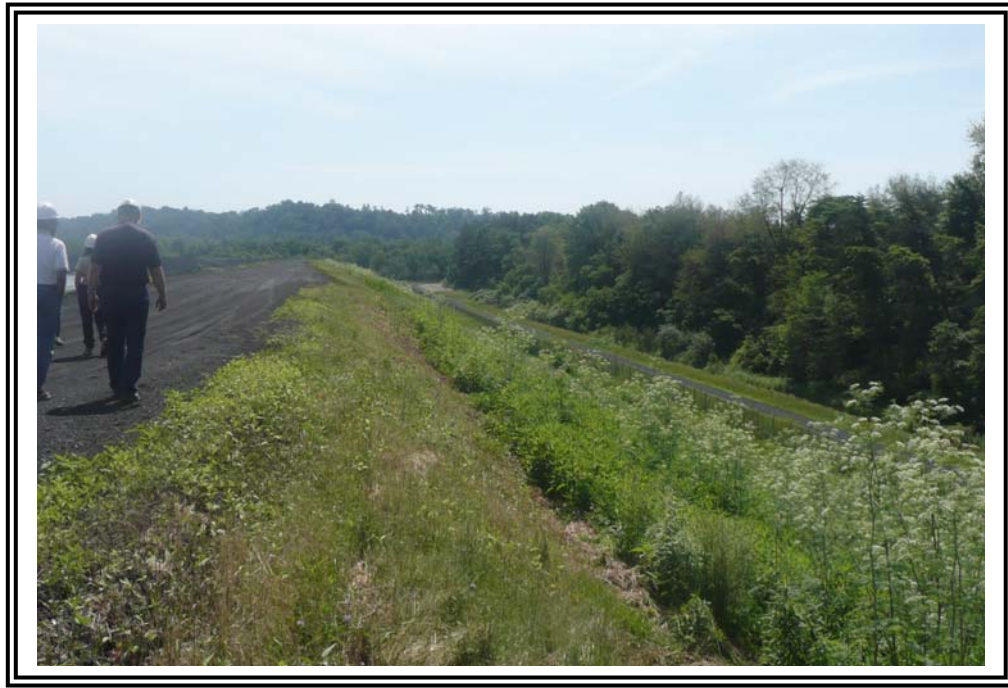
9

Downstream slope of the south berm, looking east. Note that weed-whacking was in progress and is reportedly performed twice a year.

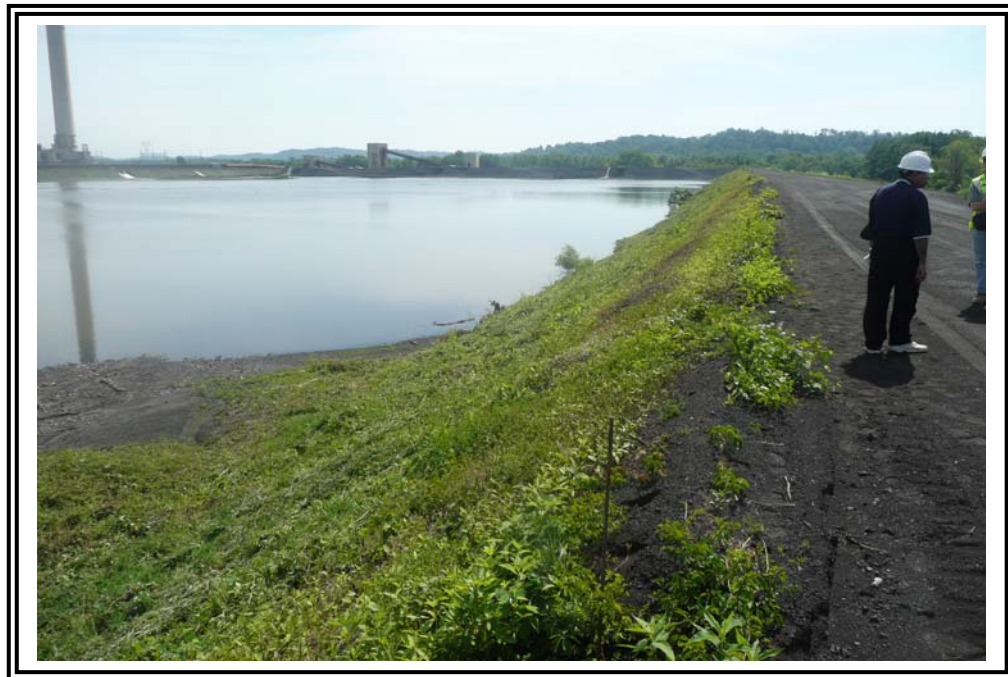
10

Upstream slope of the south dike, looking east.

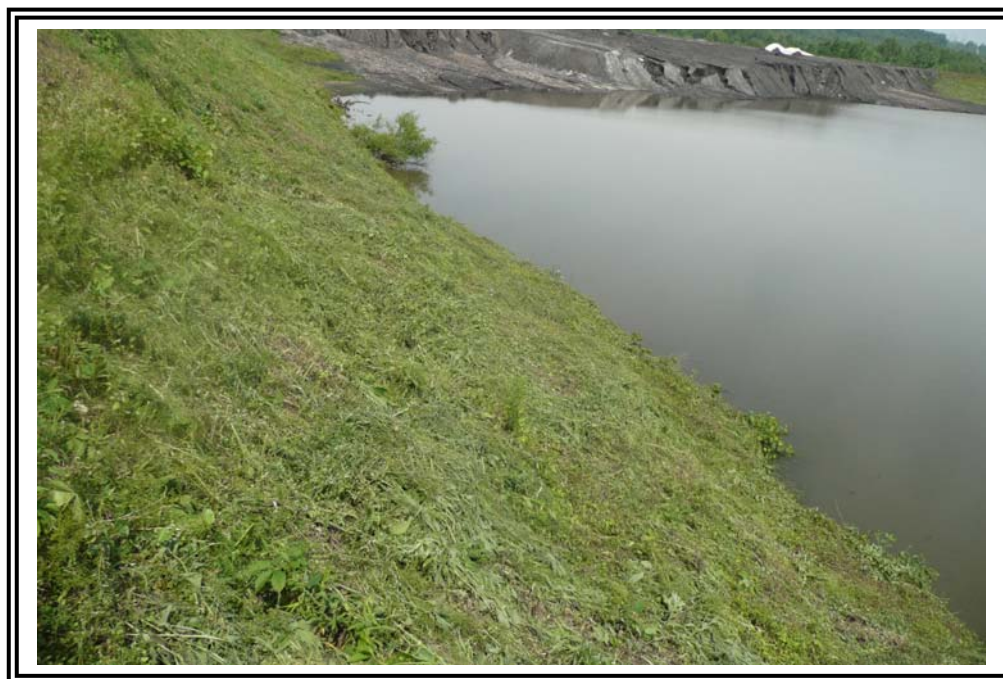
14

Close up of surficial slough on the upstream slope of the south dike, looking west.

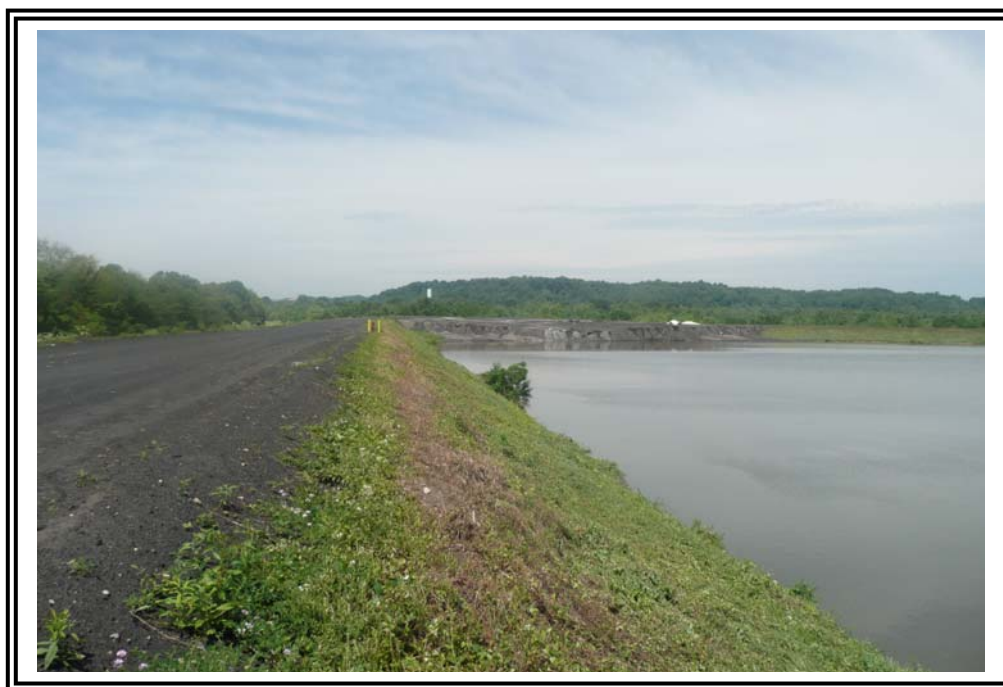
15

Upstream slope of the south dike, looking west.

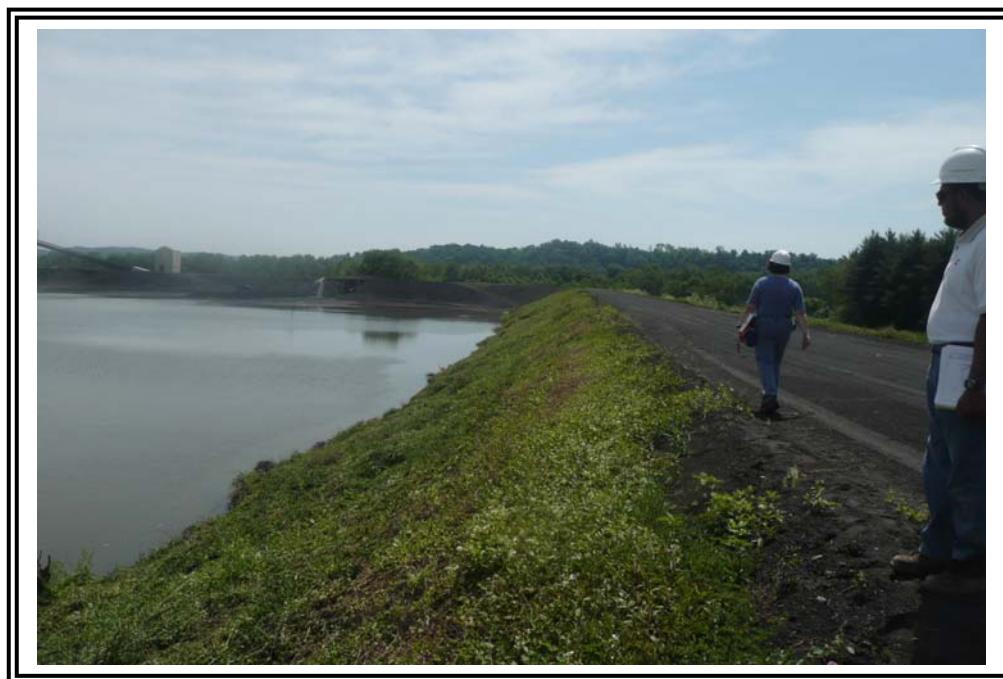
16

Upstream slope of the south dike, looking east.

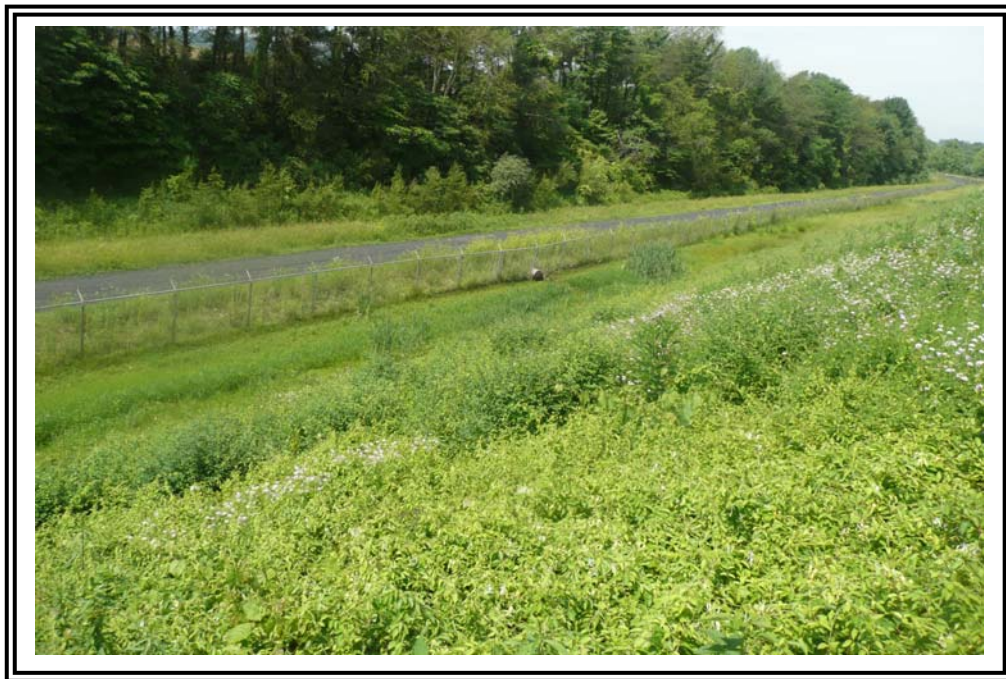
18

Downstream slope of the south dike. Note one of the re-set culverts at the fence line.

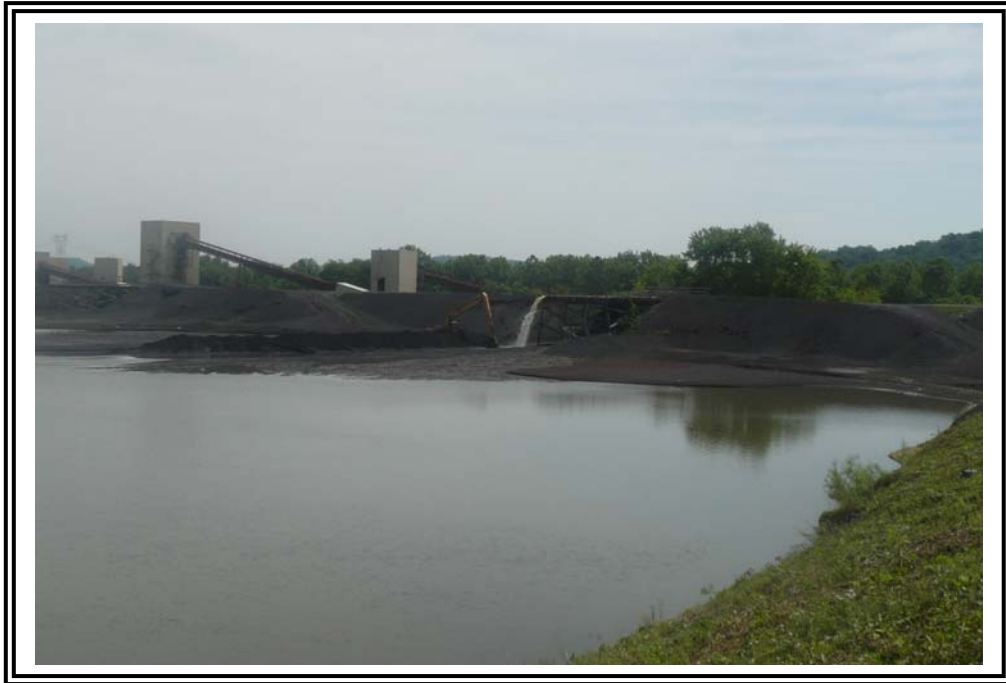
19

South end of the east dike. Bottom ash sluicing area.

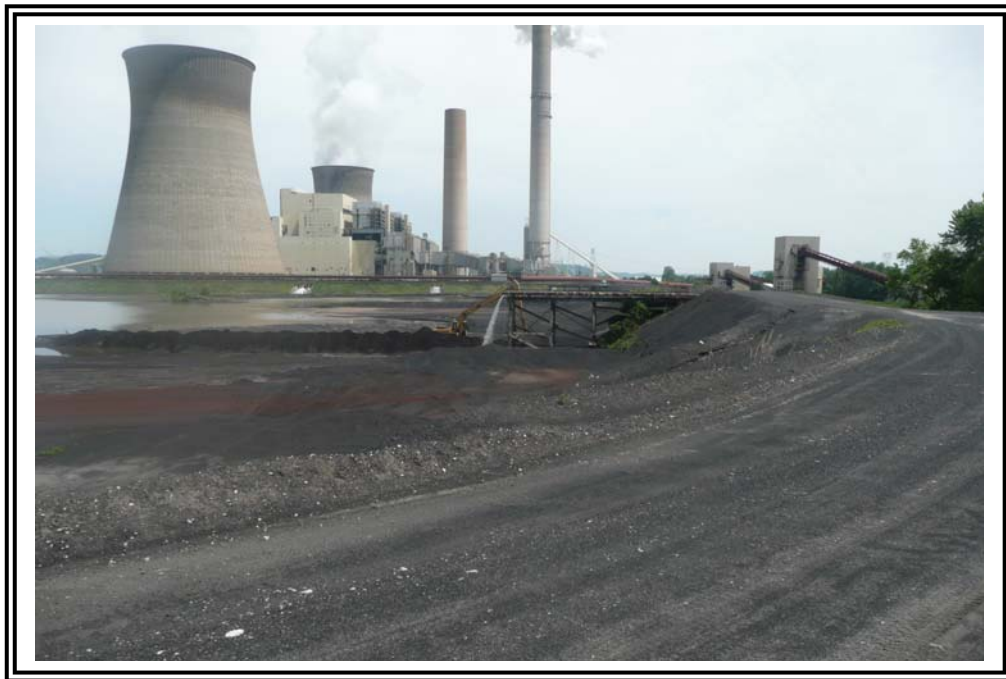
20

East end of the bottom ash pond. Bottom ash sluicing performed throughout this slope area.

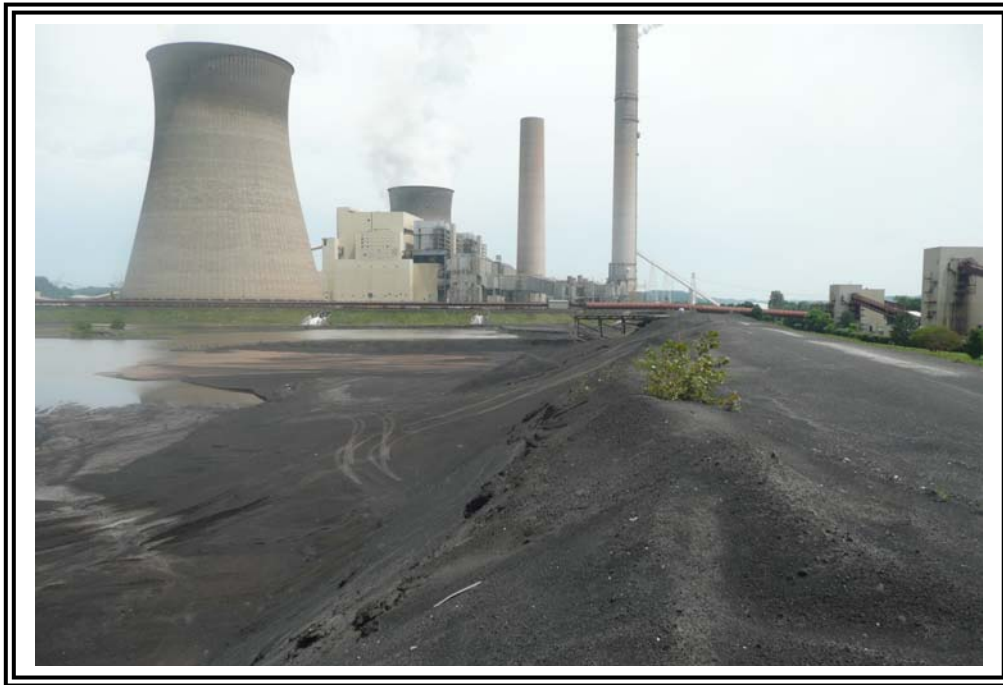
21

Ash disposal along upstream slope of east dike, looking north.

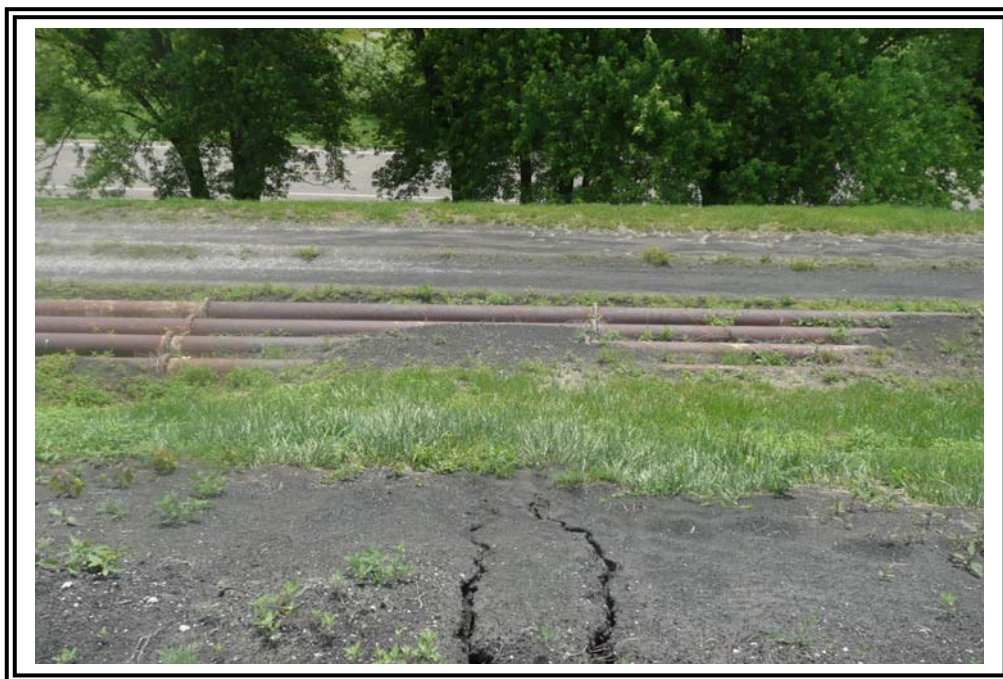
There were many areas of erosion gullies along the transition from the crest to the downstream slope. The deepest of these was 18 inches deep. There was evidence that the development of these is common and that AEP routinely repairs them as part of ongoing maintenance of the dikes. Photos 22 and 23 show a typical representation of these areas on the east dike.

Surface erosion features (typical) along graded ash at east dike upstream slope/crest transition.

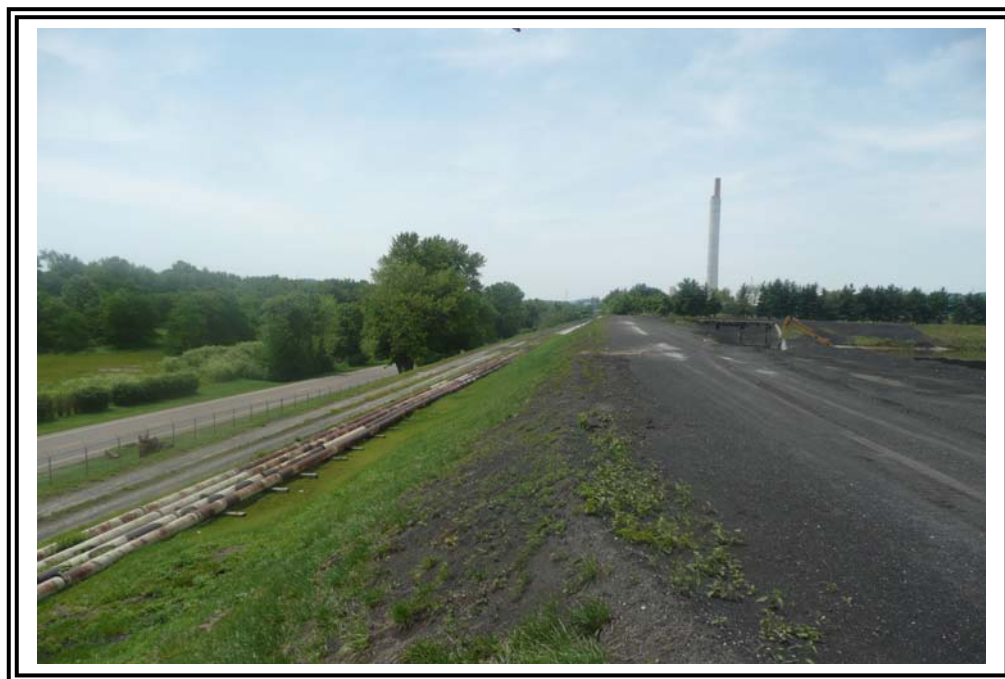
24

Crest and downstream slope alignment of east dike looking south.  
Note east dike is benched to allow an access road and sluice pipe placement.

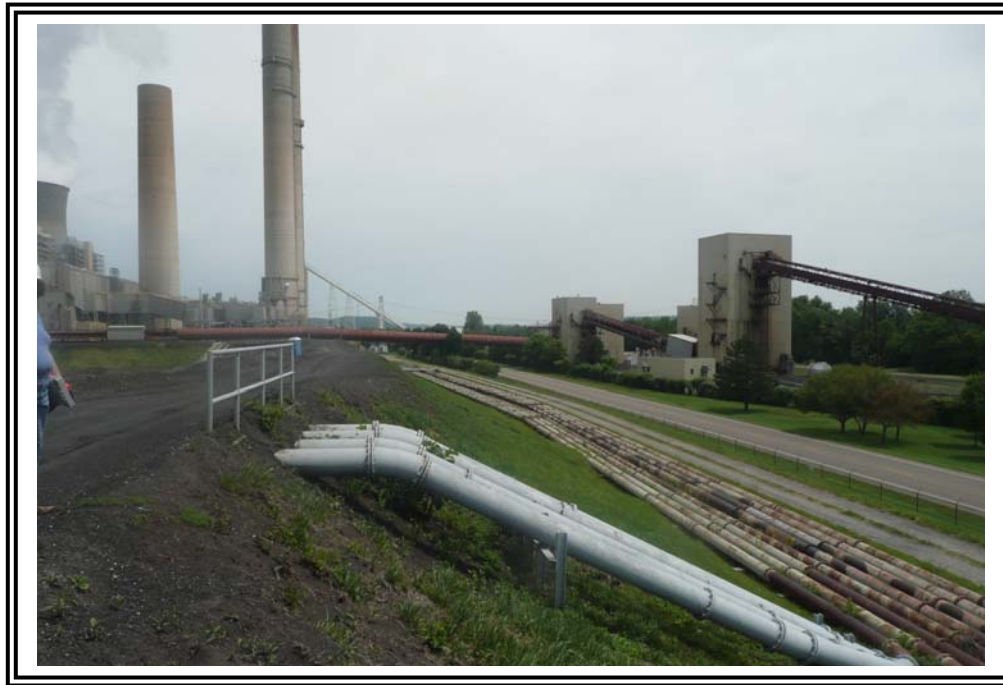
25

Crest and downstream slope alignment of east dike, looking north. Crest is raised at sluice pipe crossings.

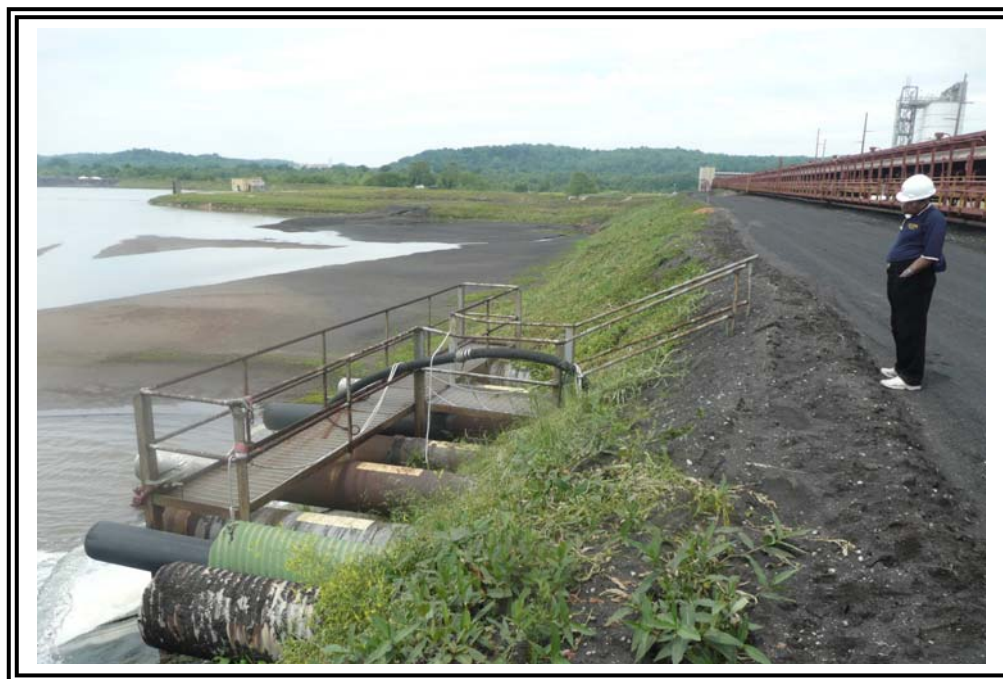
26

Crest and upstream slope alignment of north dike, looking west. Coal conveyor runs the length of the north dike crest.

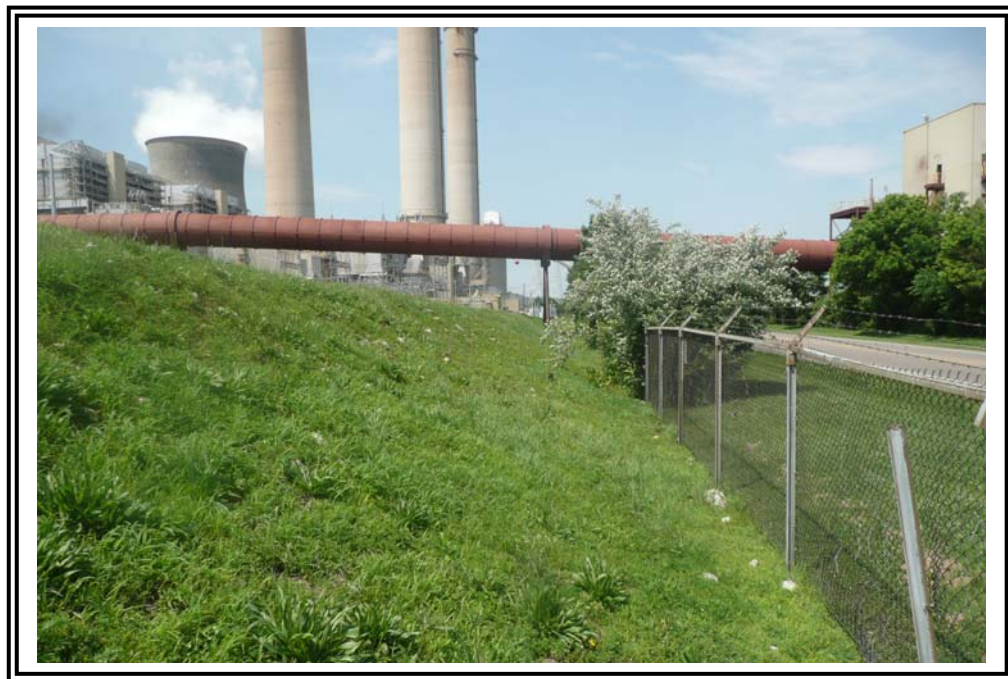
28

North end of east dike, looking north. This portion of the downstream slope is part of the benched out area for the access road.

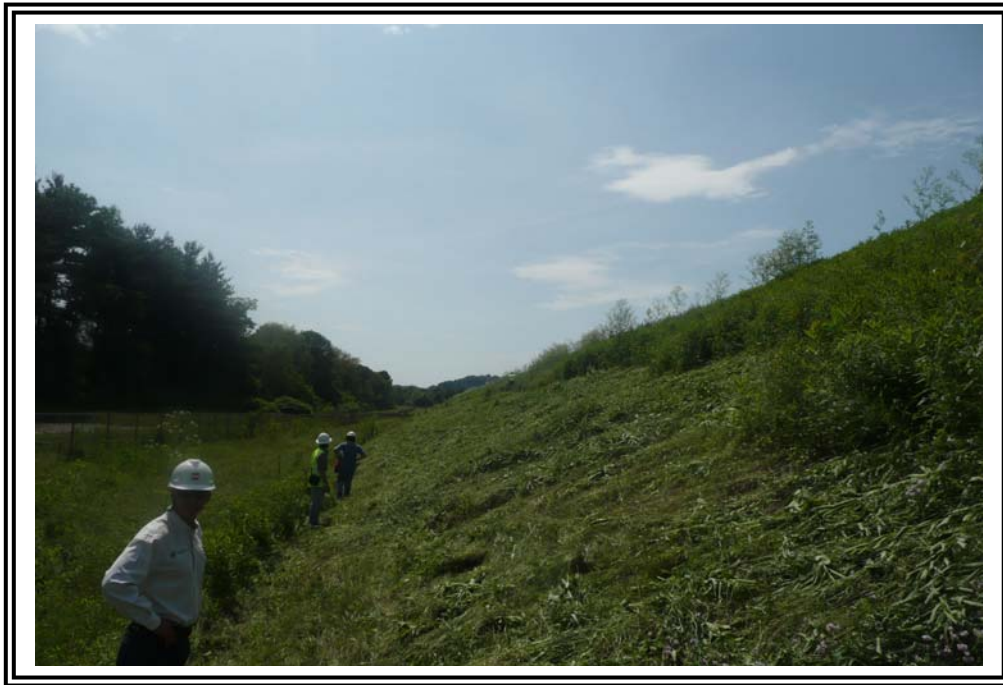
29

Downstream slope of south dike, looking west.

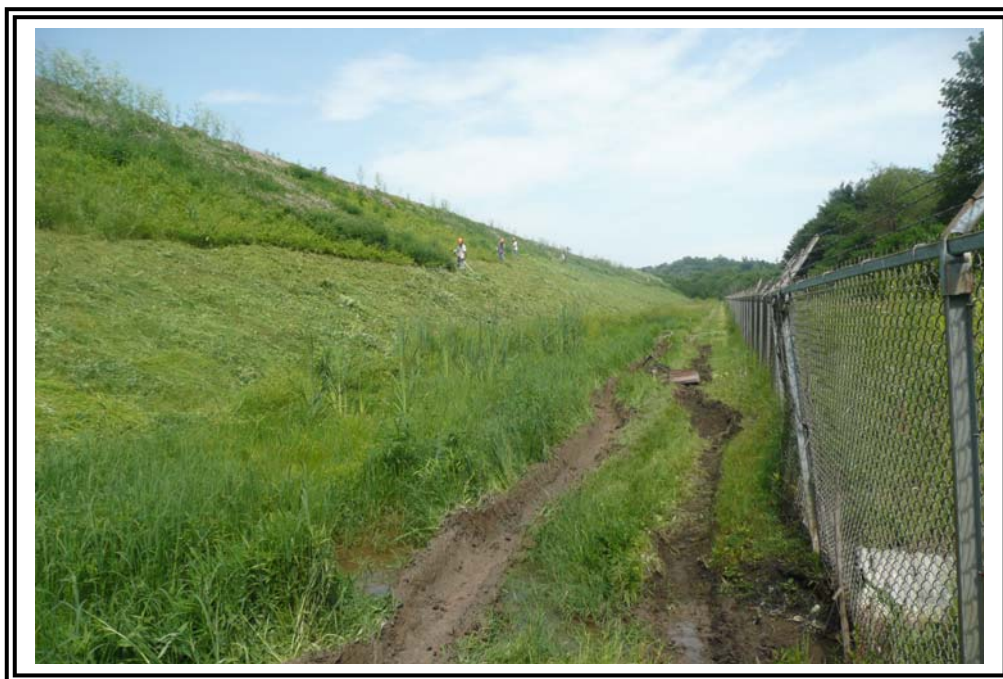
30

At about the mid point along the length of the south dike downstream slope, there is a wet area that has been noted in previous reports to be seepage. AEP personnel indicated that in February 2009 the storm water drainage from the field to the south of the Bottom Ash Pond was re-graded so rather than draining towards the Bottom Ash Pond, the runoff would run away from the Bottom Ash Pond. AEP indicated this appears to be largely improving the condition at the toe of the south dike. Piezometer readings indicate the groundwater table is about 18 feet below the toe of the south dike further suggesting that the observed water was perched on surface soil layers. No flow was observed in ponded water at the toe of the south dike.

Downstream slope of south dike, looking east. Tractor ruts are in wet area at the toe where drainage backs up. This has been previously reported as a seepage area. Recent regrading to improve surface runoff appears to have dried this area and piezometer readings indicate the water table is below the toe of the dike.

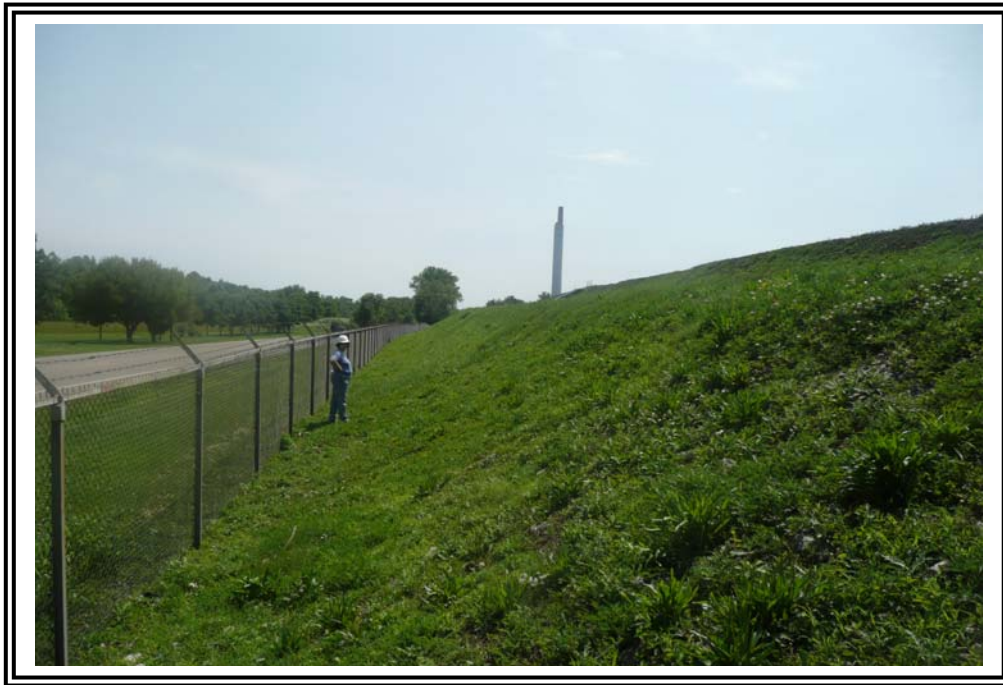
31

Downstream slope of east dike, looking south.

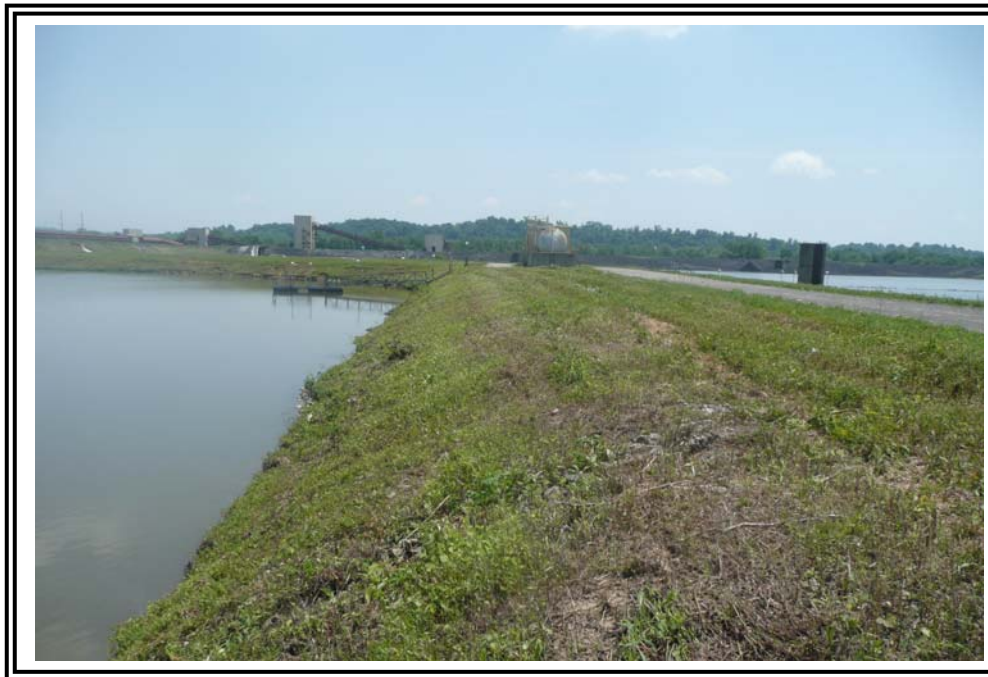
36

South intermediate dike separating primary from secondary ponds, looking east.

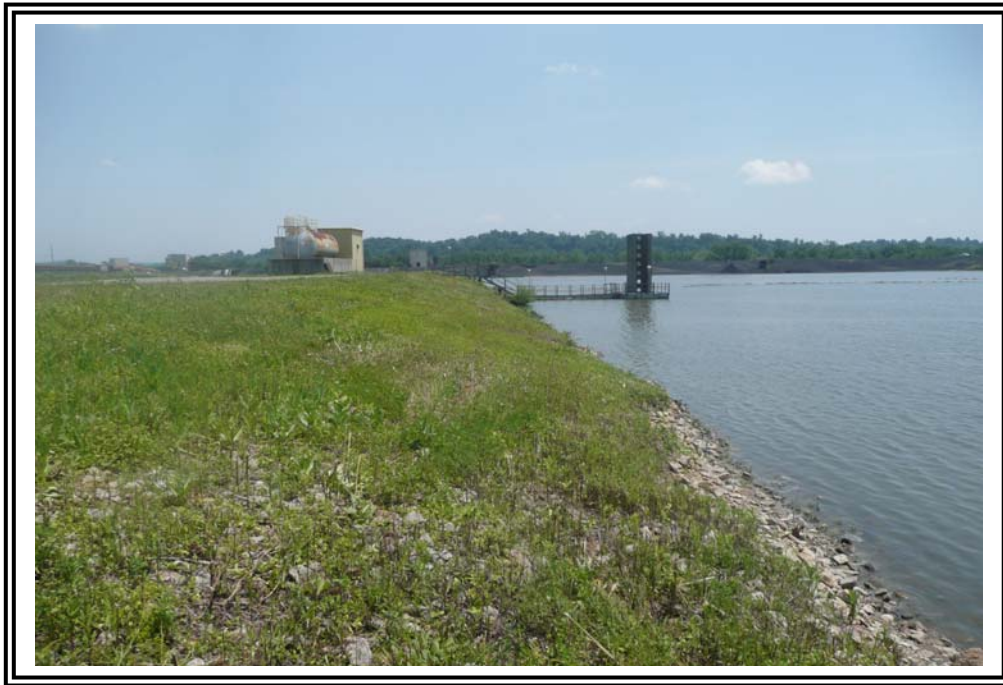
37

There are two outlet control structures in the Bottom Ash Pond. The Primary Outlet is a drop inlet structure with a concrete pipe beneath the intermediate dike. The outlet pipe was submerged and could not be observed. Photos 37, 41 and 42 show this outlet control structure.

South intermediate dike separating primary from secondary ponds, looking east.

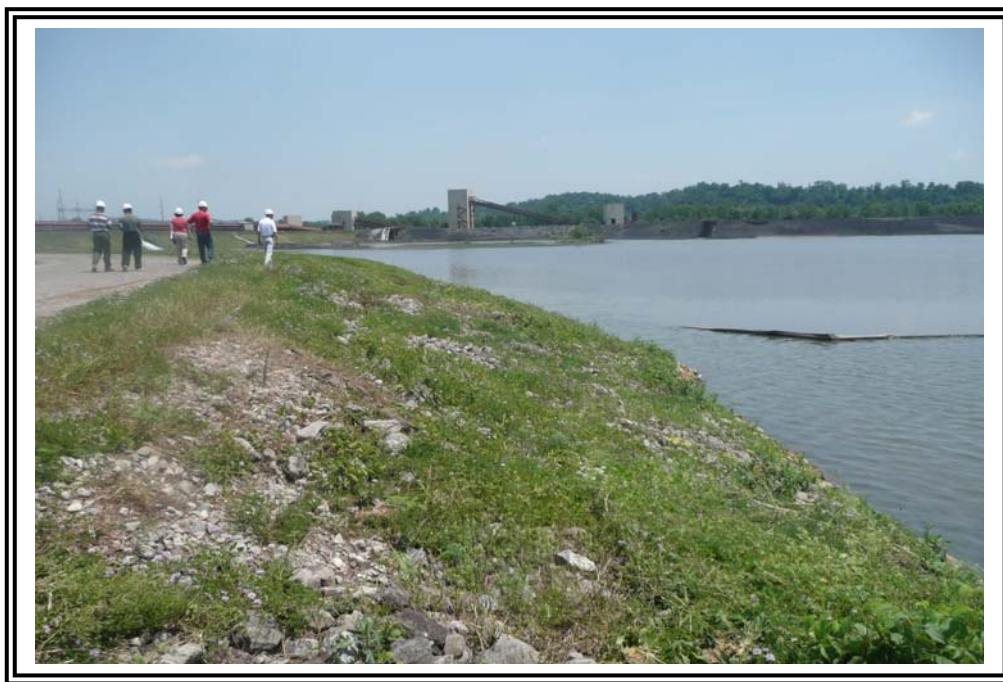
38

Intermediate dike, looking east.

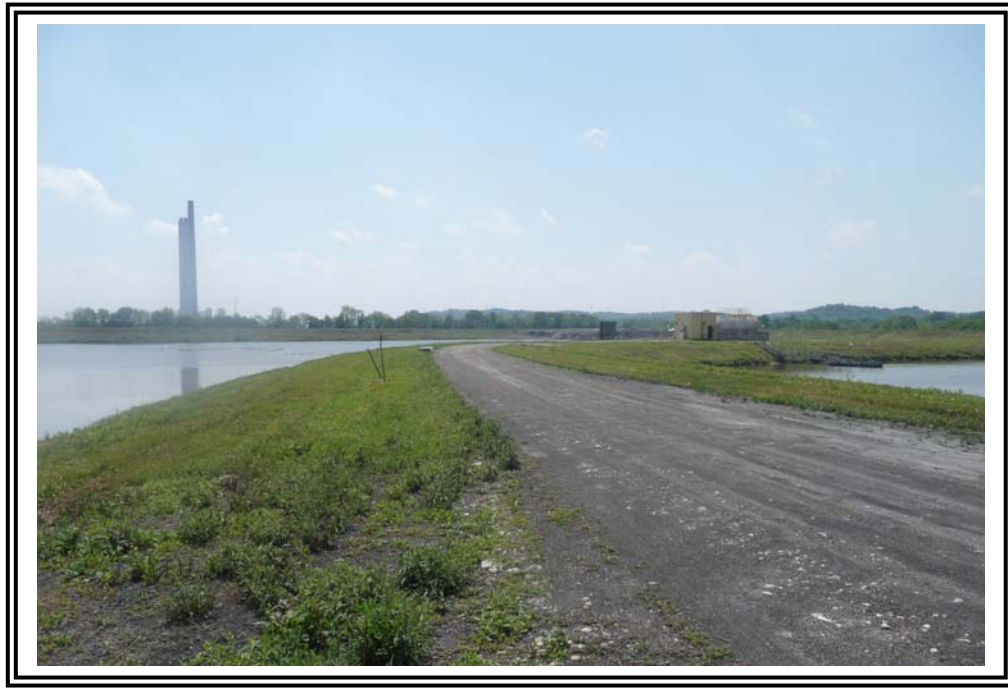
39

East intermediate dike separating primary from secondary ponds, looking south.

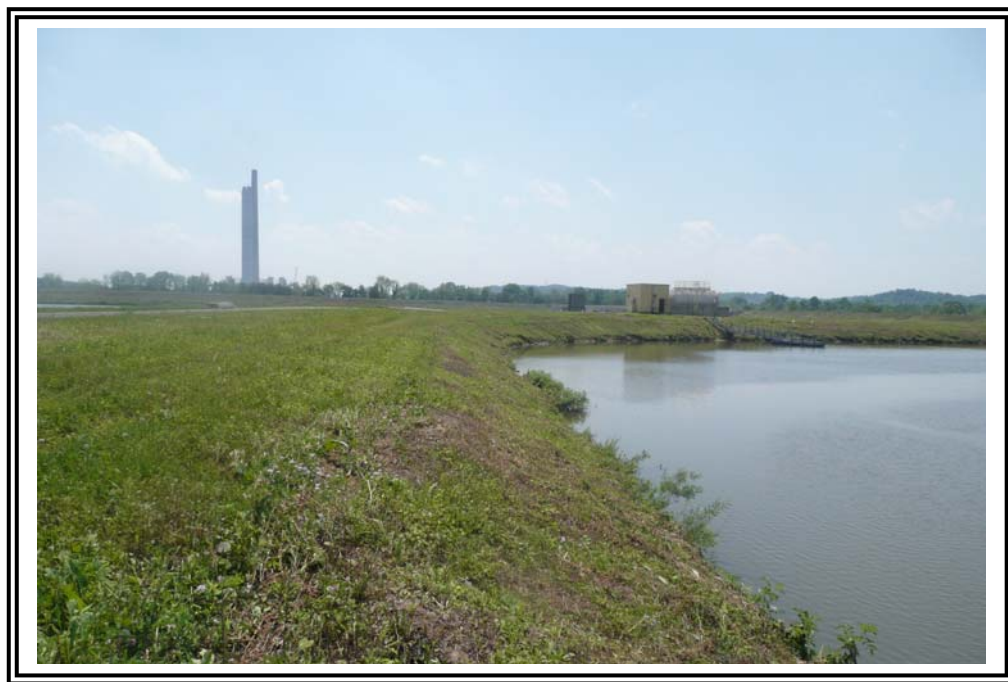
40

East intermediate dike separating primary from secondary ponds, looking south.

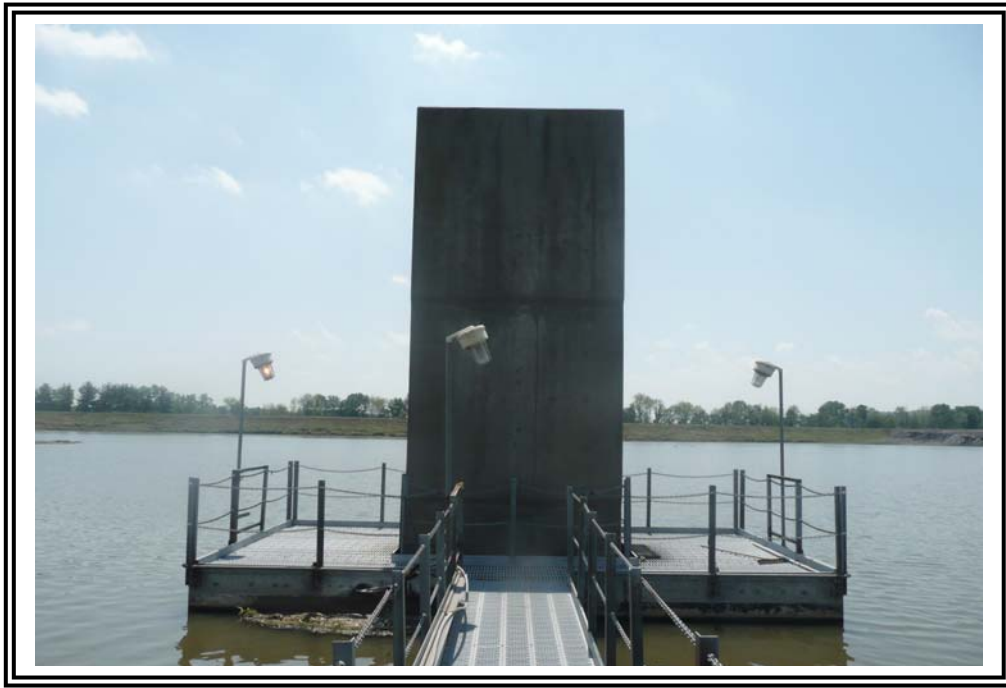
41

Main intake from primary pond to secondary pond.

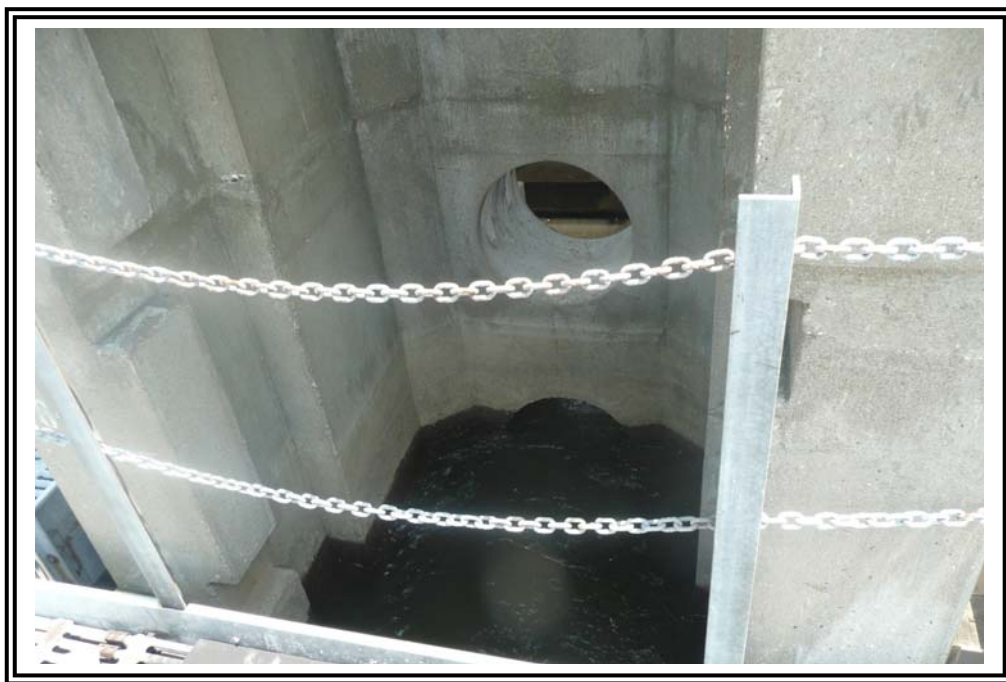
42

Main intake from primary pond to secondary pond.

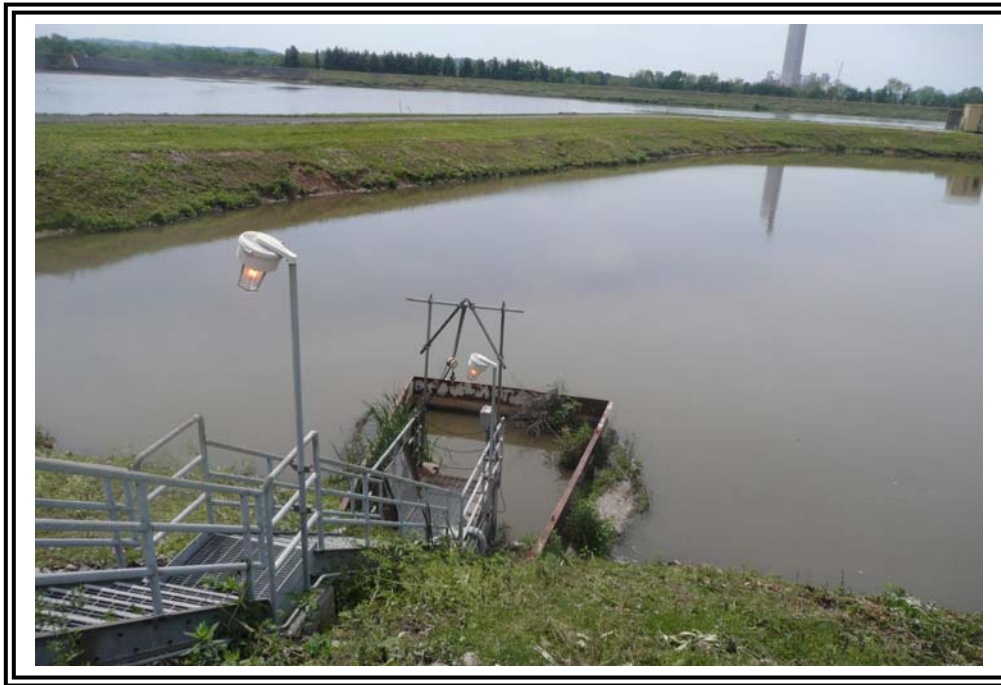
43

Outlet from secondary pond.
